**FINAL REPORT
JUNE 2001**

REPORT NO. 01-14

**PALLET, STANDARD SIZE 44 x 40, SHEET METAL,
MANUFACTURED BY
ARMOR METAL FABRICATION, INC.,
MIL-STD-1660, FIRST ARTICLE TEST (FAT)**

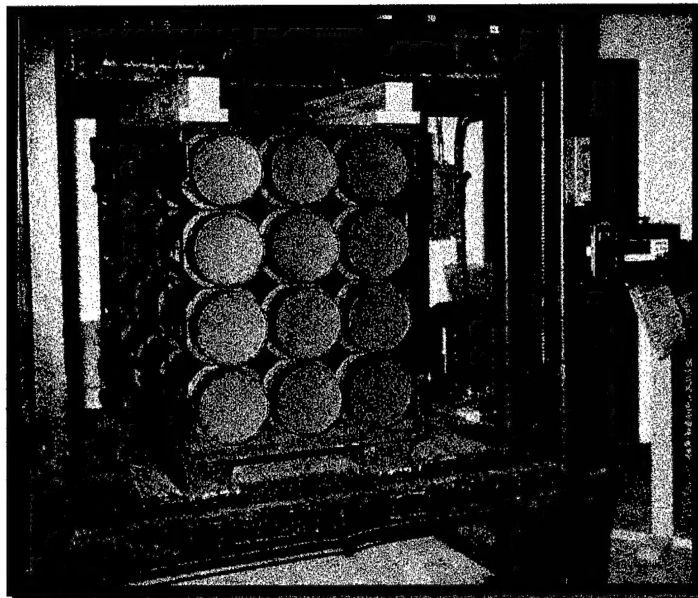
Figure 1. Example of Compression Tester.
(2.75-inch Hydra 70, PA151 Rocket Pallet in the compression tester.)

A. STACKING TEST. The unit load was tested to simulate a stack of identical unit loads stacked 16 feet high, for a period of one hour. This stacking load was simulated by subjecting the unit load to a compression weight equal to an equivalent 16-foot stacking height. The compression load was calculated in the following manner. The unit load weight was divided by the unit load height in inches and multiplied by 192 less the weight of one pallet load. The resulting number was the equivalent compressive force of a 16-foot-high load. Figure 1 below shows an example of a unit load in the compression tester.

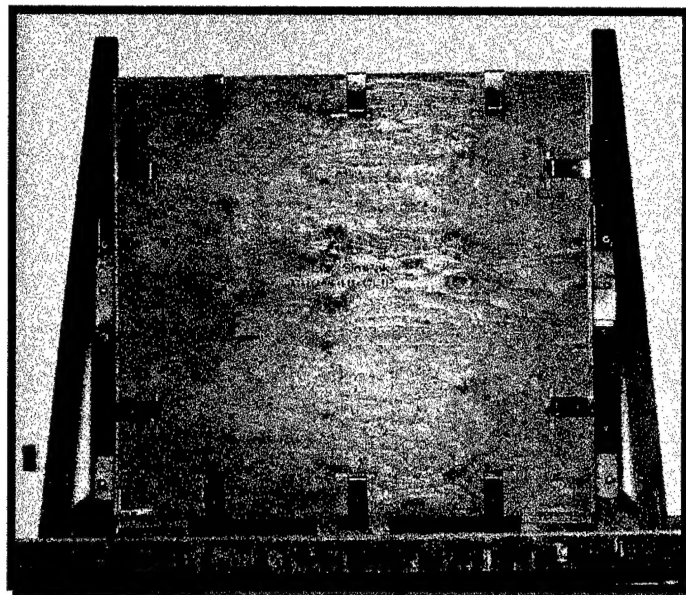
**Figure 2. Example of the Repetitive Shock Test.
("Clip-Lok" pallet on the vibration table.)**

B. REPETITIVE SHOCK TEST. The repetitive shock test was conducted IAW Method 5019, Federal Standard 101. The test procedure is as follows: The test specimen was placed on (not fastened to) the platform. With the specimen in one position, the platform was vibrated at 1/2-inch amplitude (1-inch double amplitude) starting at a frequency of approximately 3 cycles-per-second. The frequency was steadily increased until the package left the platform. The resonant frequency was achieved when a 1/16-inch-thick feeler gage momentarily slid freely between every point on the specimen in contact with the platform at some instance during the cycle. Midway into the testing period, the specimen was rotated 90 degrees, and the test continued for the duration. Unless failure occurred, the total time of vibration was three hours. Figure 2 shows an example of the repetitive shock test.

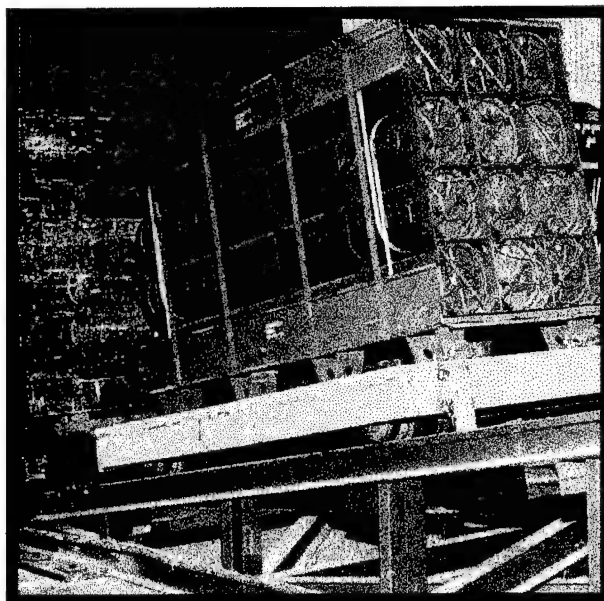
Figure 4. Example of the Incline-Impact Test.
(2.75-Inch, Hydra 70, PA151 Rocket Pallet on incline-impact tester.)

D. INCLINE-IMPACT TEST. This test was conducted by using the procedure of Method 5023, Incline-Impact Test of Federal Standard 101. The procedure for the incline-impact test is as follows: The specimen was placed on the carriage with the surface or edge to be impacted projecting at least 2 inches beyond the front end of the carriage. The carriage was brought to a predetermined position on the incline and released. If it were desired to concentrate the impact on any particular position on the container, a 4- x 4-inch timber would be attached to the bumper in the desired position before the test. The carriage struck no part of the timber. The position of the container on the carriage and the sequence in which surfaces and edges were subjected to impacts was at the option of the testing activity and depended upon the objective of the test. This test was to determine satisfactory requirements for a container or pack, and, unless otherwise specified, the specimen was subjected to one impact on each surface that has a dimension of less than 9.5 feet. Unless otherwise specified, the velocity at the

time of the impact was 7 feet-per-second. Figure 4 shows an example of this test.

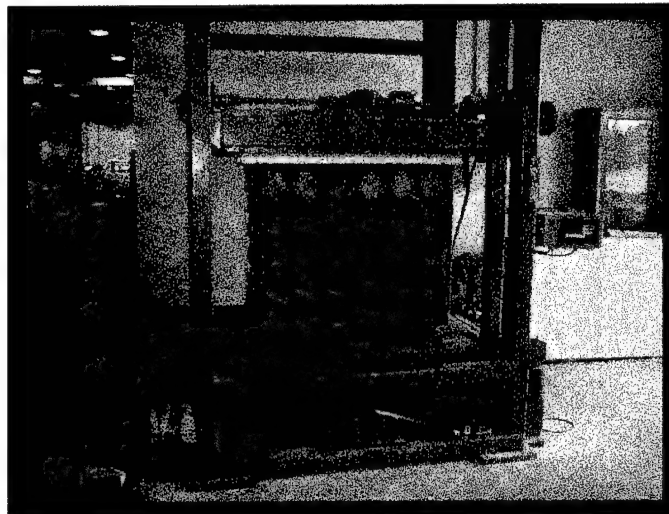
Figure 5. Test setup of Compression Test.

1. **Compression Test**. Test Pallet 2A was compressed with a load force of 9,200 pounds for 60 minutes on 16 May 2001. No damage was noted as a result of this test. See Figure 5 for test setup.

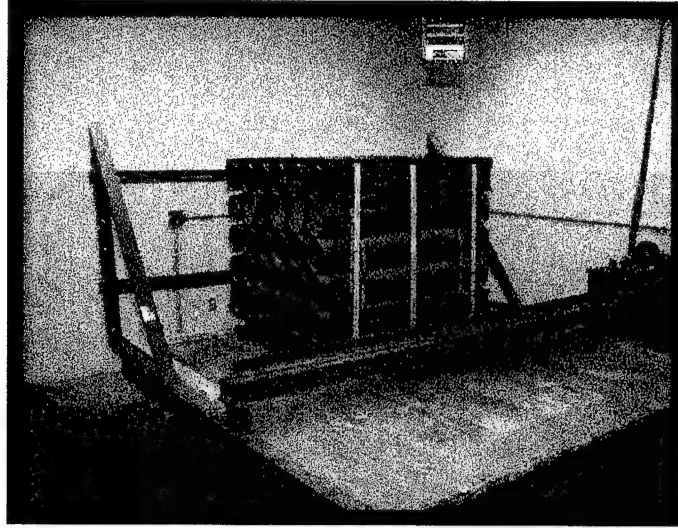
Figure 6. Test setup of Repetitive Shock Test.

2. **Repetitive Shock Test.** Test Pallet 2A was vibrated 90 minutes at 171 RPM in the longitudinal orientation and 90 minutes at 180 RPM in the lateral orientation. There was no damage to the pallet as a result of this test. See figure 6 for test setup.

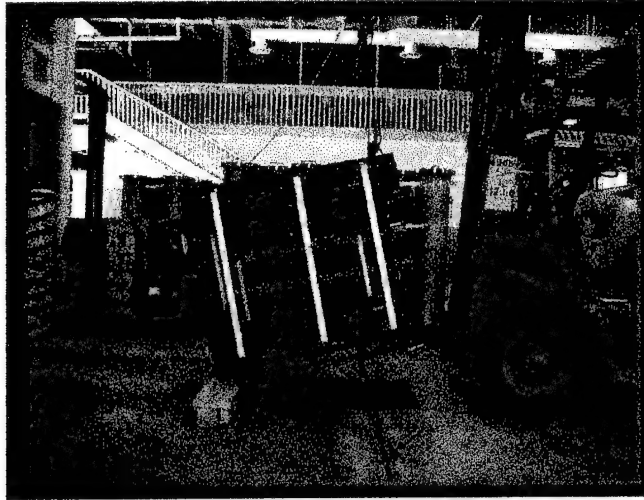
Figure 7. Test setup of Edgewise Rotational Drop Test.

3. **Edgewise Rotational Drop Test.** Test Pallet 2A was edgewise rotationally dropped from a height of 15 inches on the longitudinal and 15 inches on the lateral drops. The post skid welds broke in several places, but it should be noted that there were no post deck welds broken. The damage was deemed to be minor with further inspection to be done during disassembly of the pallet. See Figure 7 for test setup.

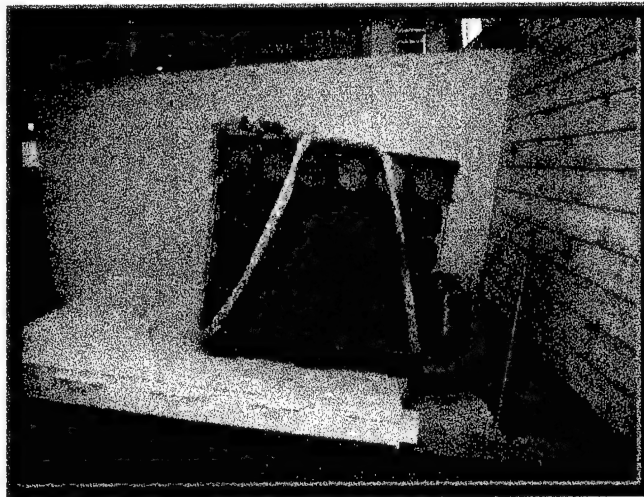
Figure 8. Test setup of Incline-Impact Test.

4. Incline-Impact Test. Test Pallet 2A was incline-impacted on all four sides with the pallet impacting the stationary wall from a distance of 8 feet. Again, no additional problems were encountered. See figure 8 for test setup.

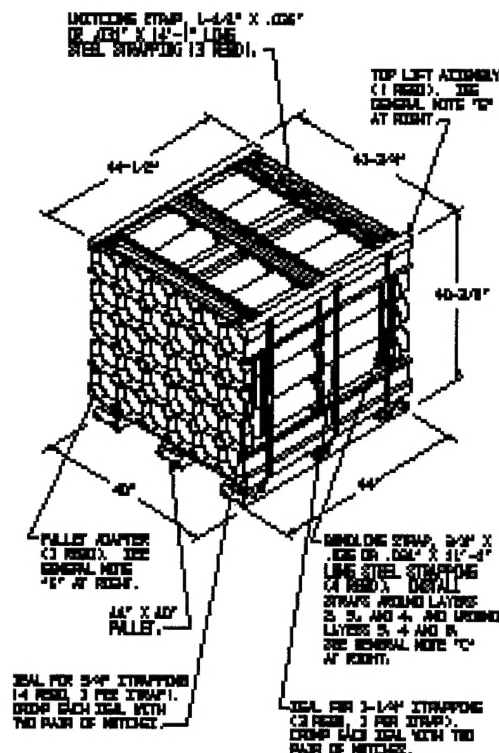
PALLET UNIT

CARTRIDGE, 105MM. PACKED 1 PER PA117
CYLINDRICAL METAL CONTAINER, UNITIZED 30
PER 44" X 40" PALLET; APPROX CONTAINER
SIZE 44-1/2" L X 6-7/8" W X 6-7/8" H

The following drawing represents the load configuration that was subjected to the test criteria. The final load drawing is AMC Drawing # 19-48-4231/45-20PM1006. This drawing may be located at:
